## **RIVER RESTORATION**

## Revetments

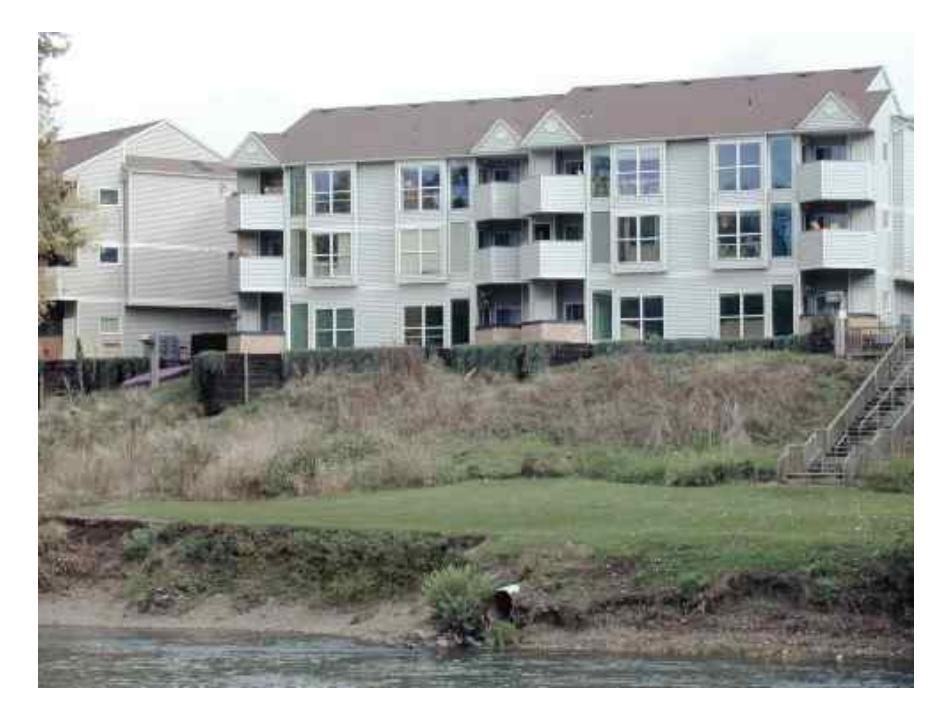
Figure 189. Bank protection and drainage for new apartment buildings in the riparian area of the Willamette River in Salem.

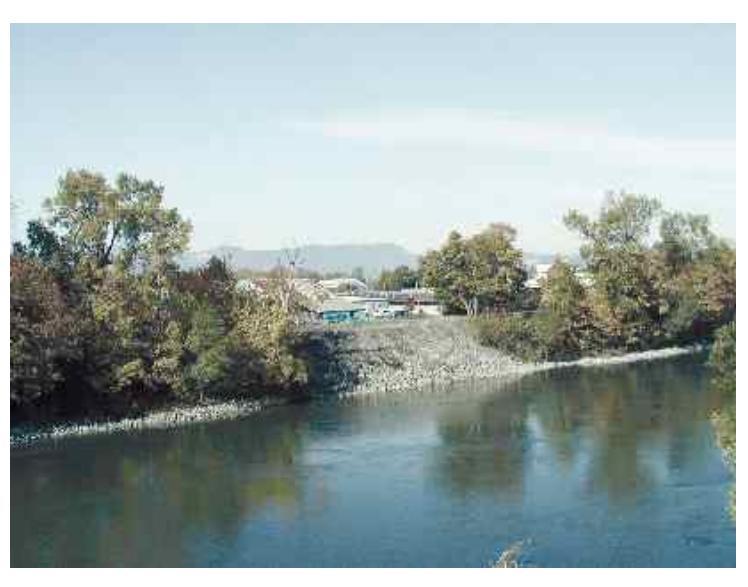
Figure 187. Bank revetment used to repair a slump that occurred on the river bank of the Willamette River in Corvallis during the flood of February 1996.

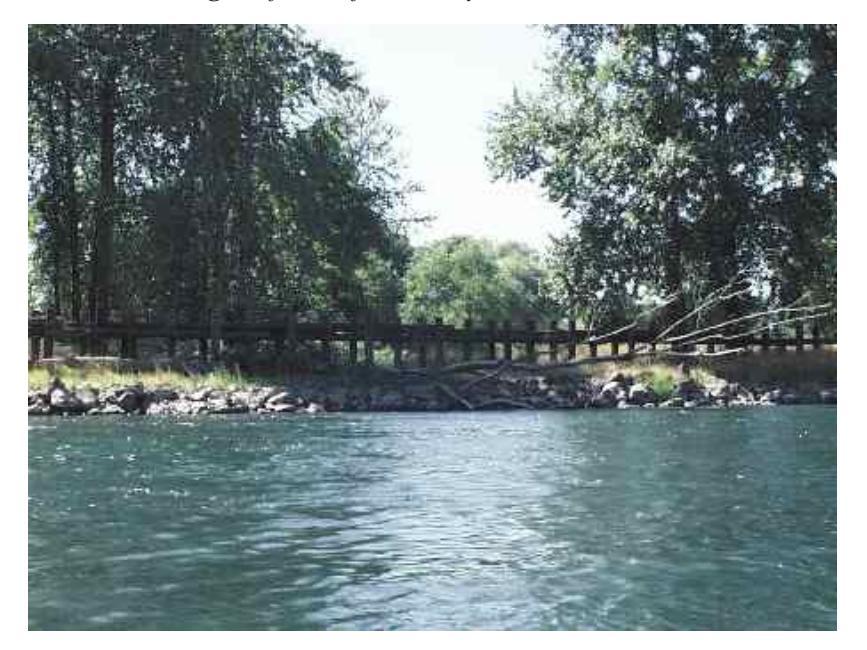
Figure 188. Blockage of historical side channel and armoring with riprap in the upper Willamette River.

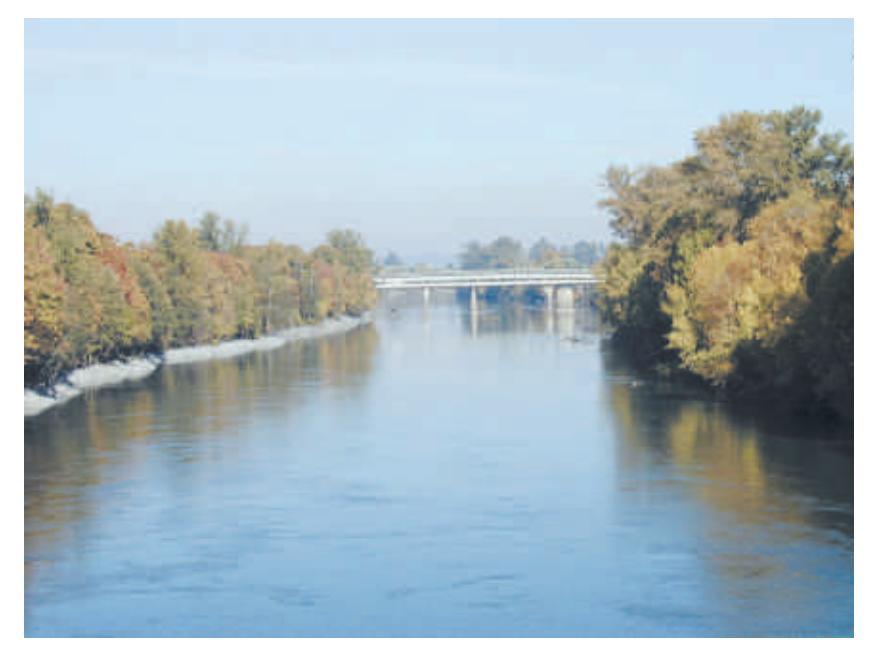
Figure 191. Fringe of native riparian vegetation with riprap to stabilize the lower bank in Corvallis.
